## **Monuments & Plaques Inventory**

## **Condition Assessment of the PSSR Monuments & Plaques**

Conducted for Pennsylvania Society of Sons of the Revolution

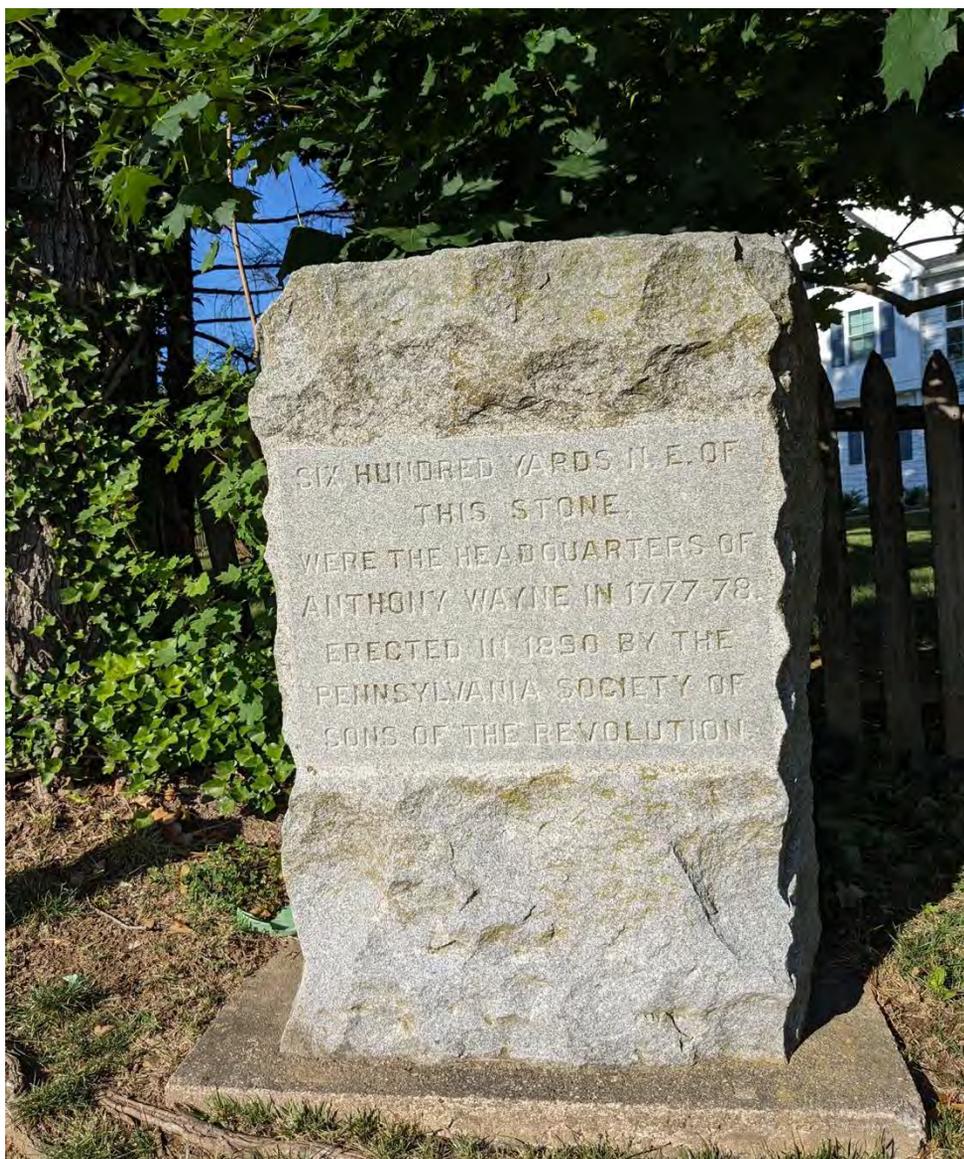
## **1890 Stone Monument General Wayne's Headquarters**

**Condition Assessment:** Discoloration of the granite is due to air born pollutants and organic growth from the existing vegetation surrounding the monument.

**Action Needed:** Cleaning

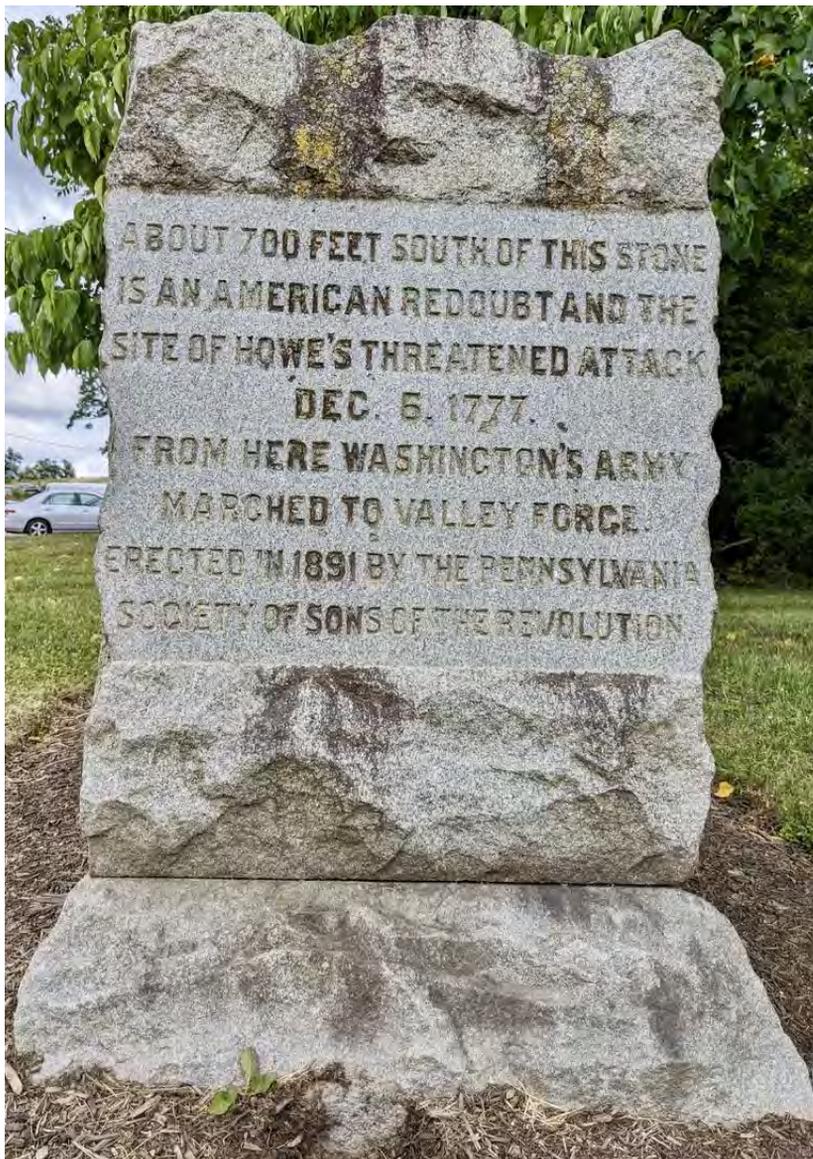
## **1891 Stone Monument March To Valley Forge Dec. 11, 1777**

**Condition Assessment:** Discoloration of the granite is due to air born pollutants and organic growth from the existing vegetation surrounding the monument.

**Action Needed:** Cleaning and Pointing

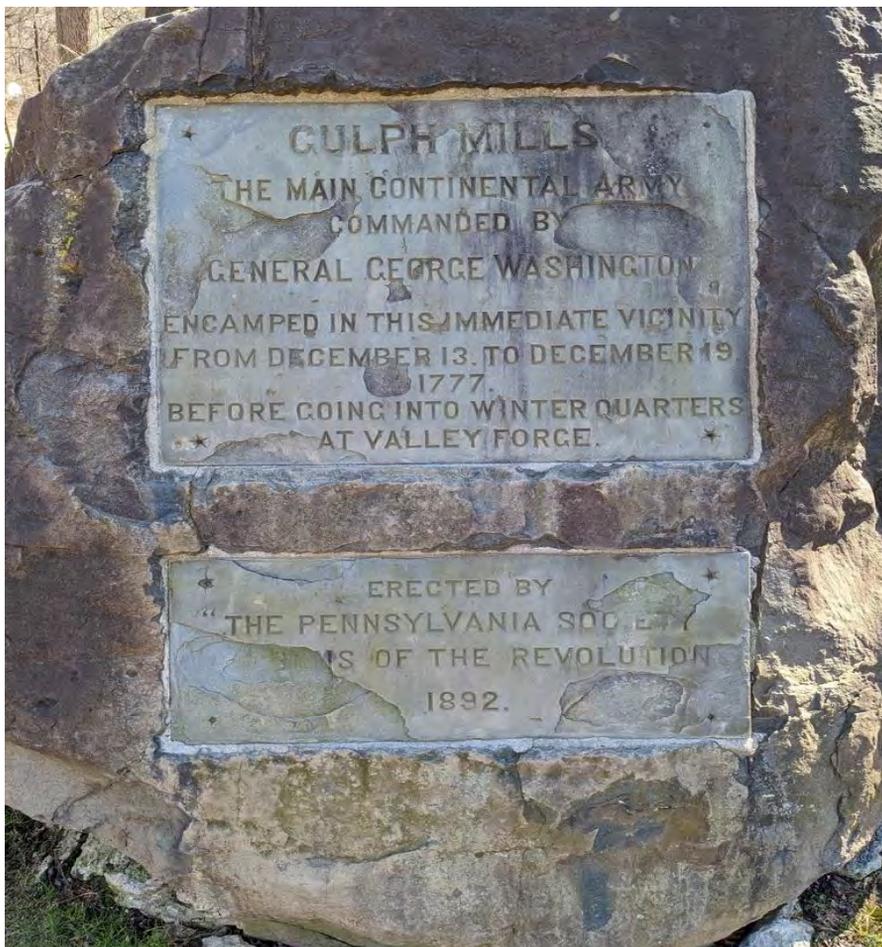
## 1893 Stone Monument Continental Army Encamped December 12 – 19, 1777

**Condition Assessment:** Boulder is leaning and in danger of falling over due to an inadequate foundation underneath. The 3 stone plaques need to be replaced due to a condition called spalling (The delamination of the face of stone).

**Action Needed:** Currently working on relocating the boulder to Gulph Mills in the vicinity of the original encampment. **This is of high priority.**

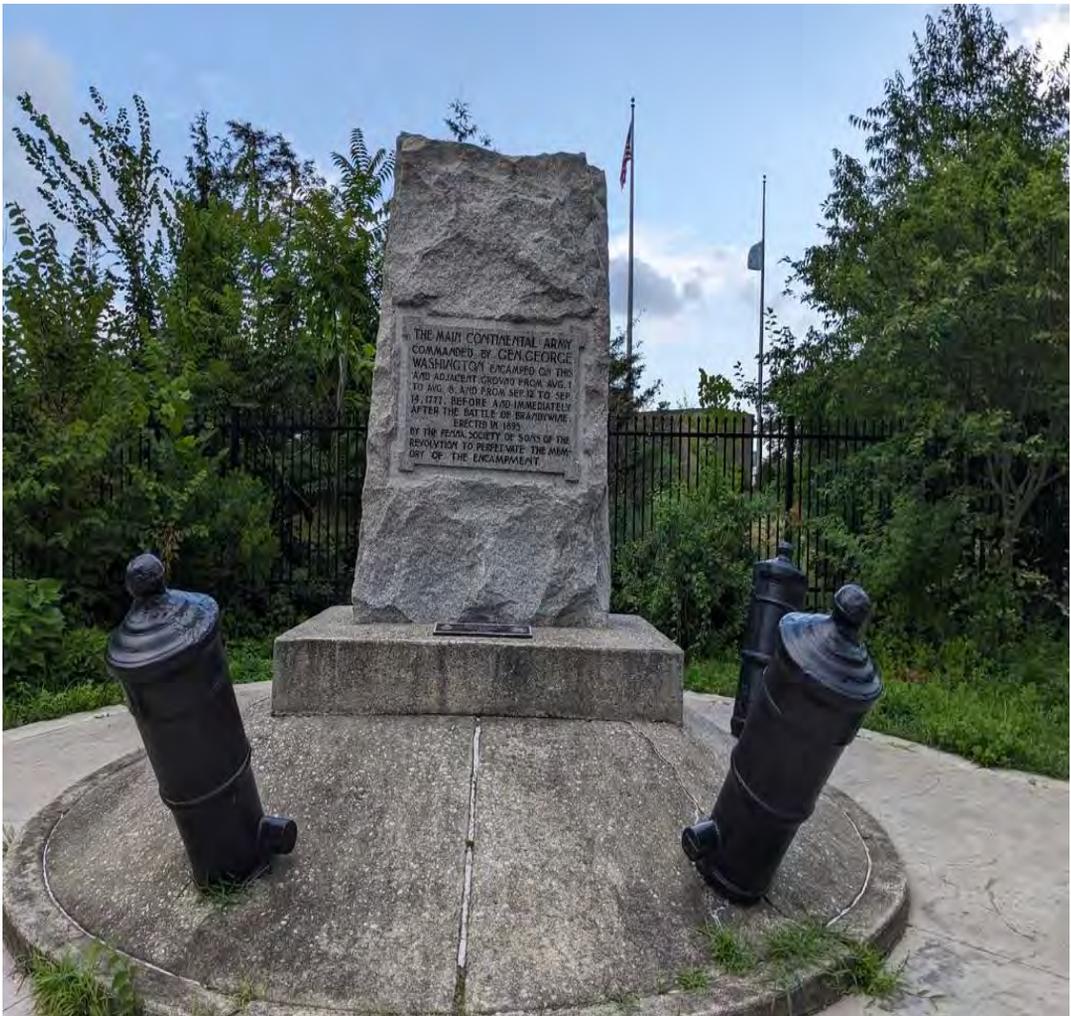
**1895 Stone Monument Continental Army Encamped  
August 1 – 9, 1777 and September 12 – 14, 1777**

**Condition Assessment:** This monument was restored in 2017

**Action Needed:** No action required.

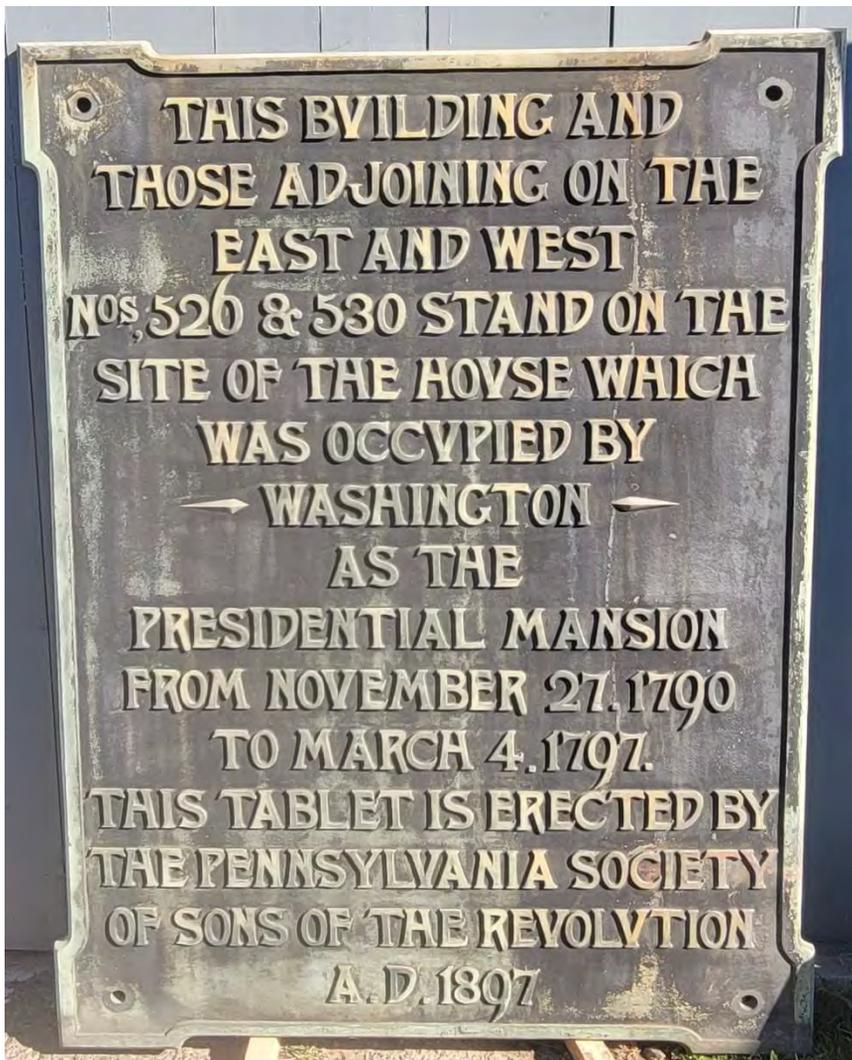
## 1897 Bronze Plaque Presidential Mansion 1790 -1797

**Condition Assessment:** Degradation of the bronze by acid rain (primarily copper sulfates) due to exposure of outdoor environment.

**Action Needed:** Recommend a general cleaning of the bronze. Apply a coat of micro-crystalline wax to protect the bronze from future erosion OR buffing and highlighting of the letters and applying a protective clear coat.

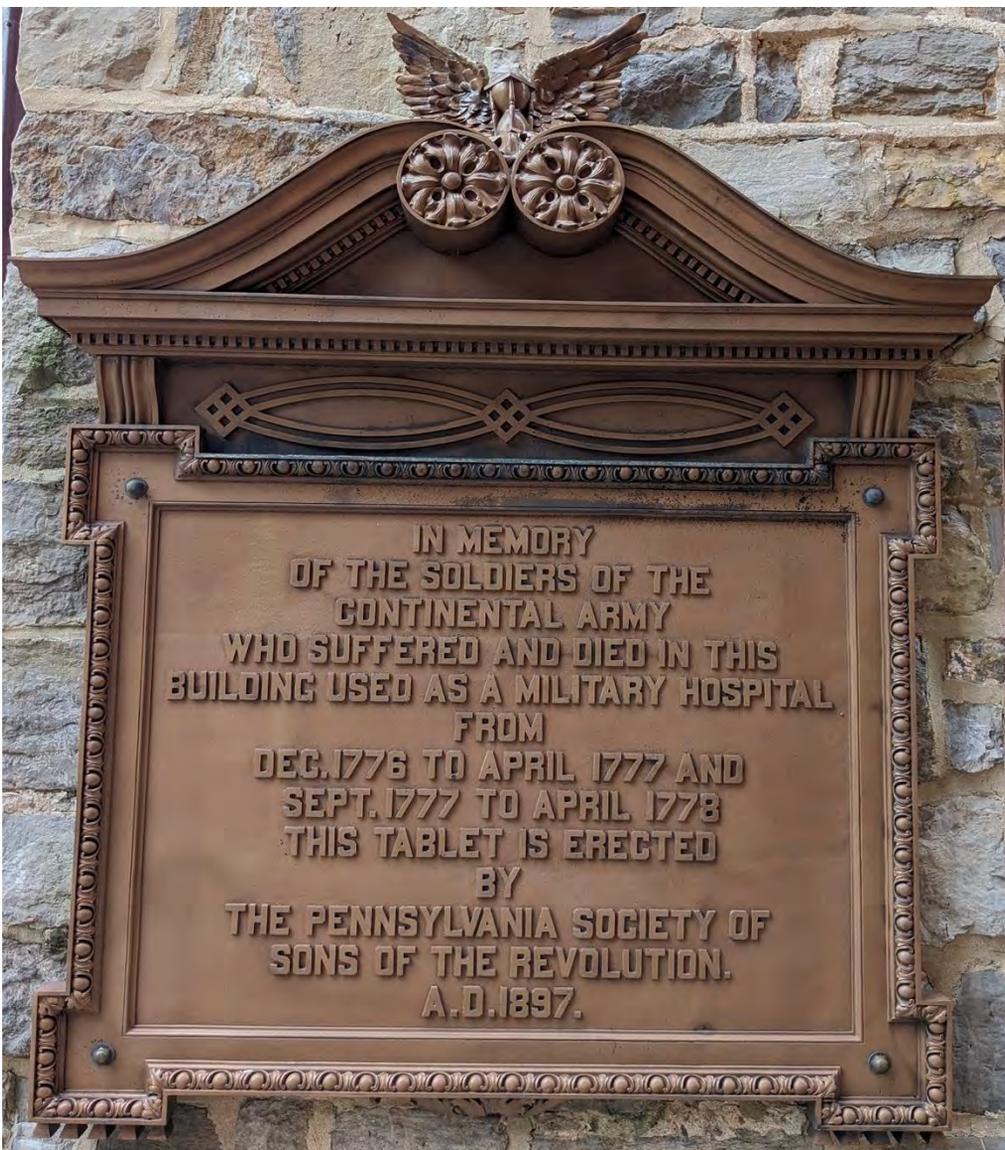
## 1897 Bronze Plaque Continental Army Hospital

**Condition Assessment:** A very amateur spray paint job and pointing splats of mortar on the face of the bronze.

**Action Needed:** Plaque needs to be stripped, re-highlighted and clear coated.

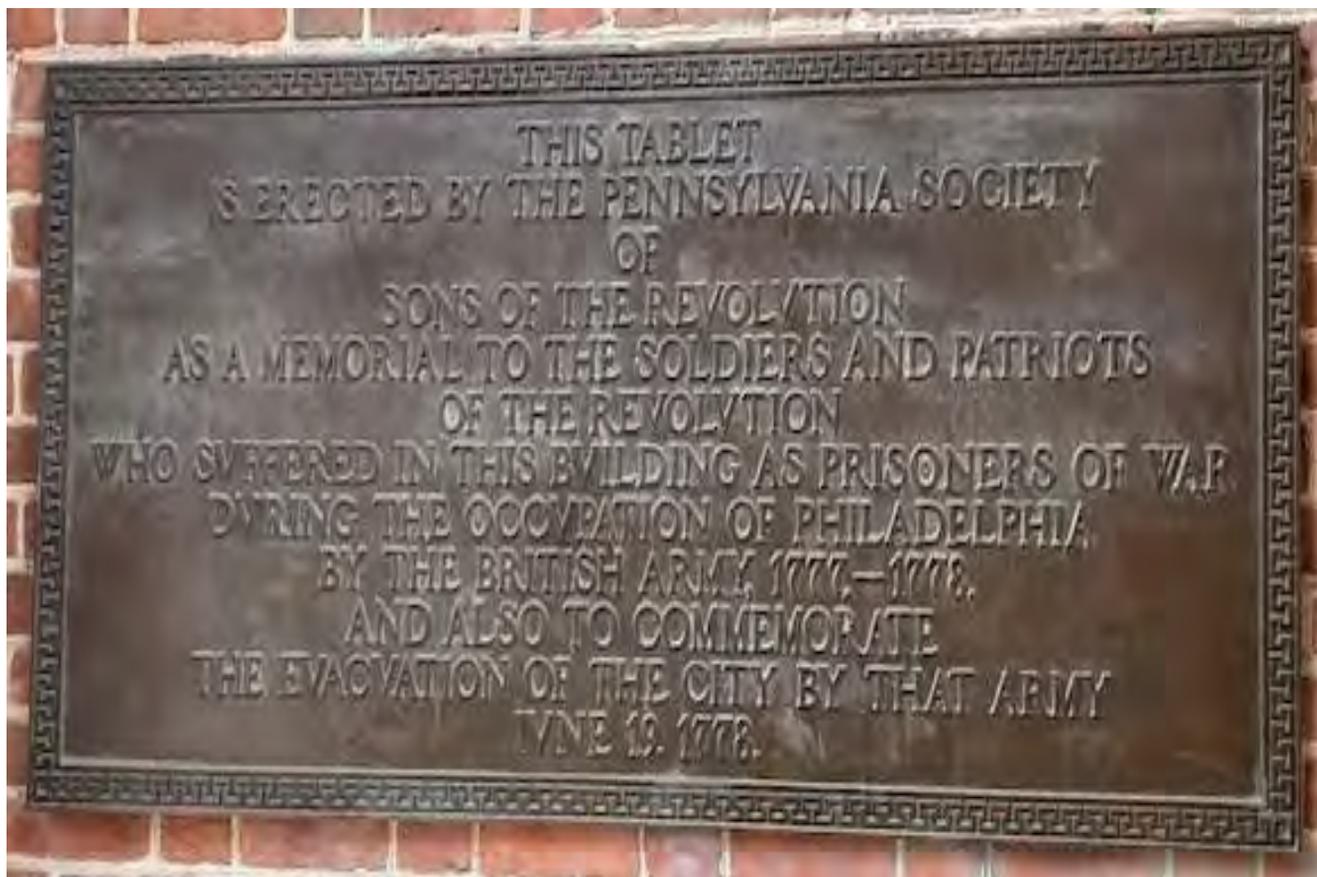
## 1905 Bronze Plaque \_ Prison during British Occupation of Phila. 1777-1778

**Condition Assessment:** Good condition due to being semi-protected from the elements.

**Action Needed:** This Plaque could use restoration, however the plaque is located on National Park Property.

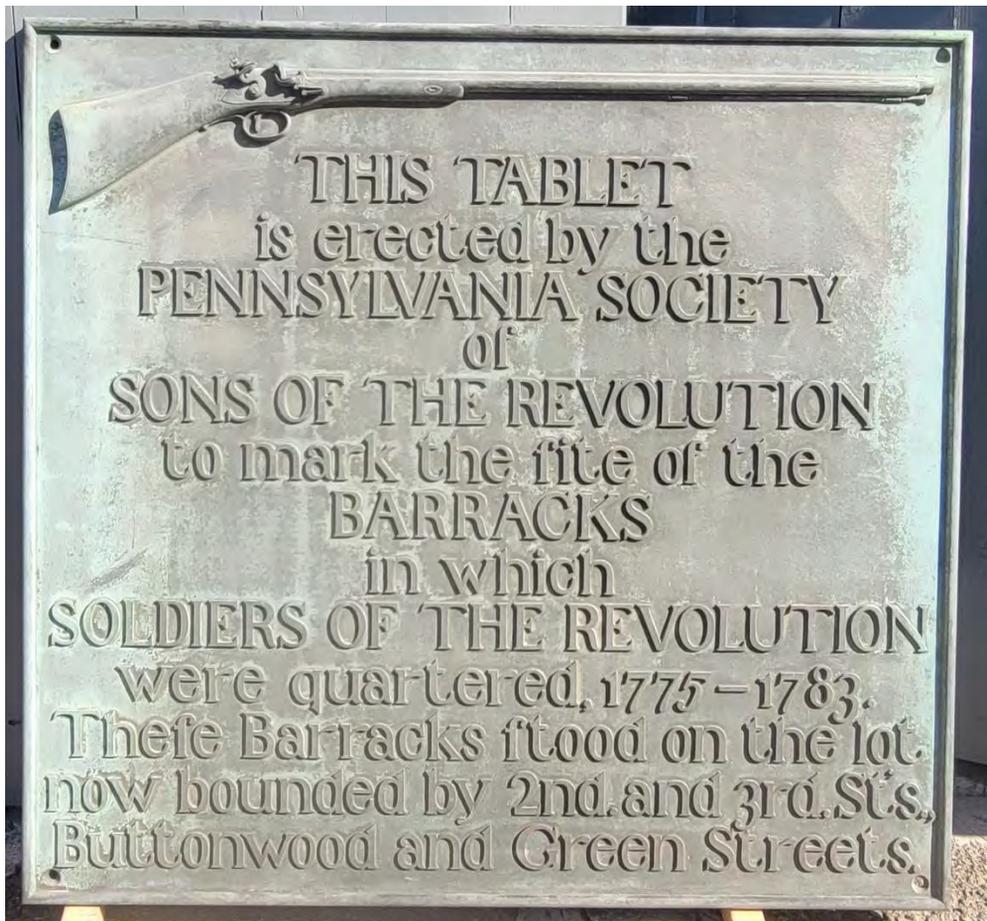
## 1905 Bronze Plaque Barracks, 1756 - 1783

**Condition Assessment:** Degradation of the bronze by acid rain (primarily copper sulfates) due to exposure of outdoor environment.

**Action Needed:** Recommend a general cleaning of the bronze. Apply a coat of micro-crystalline wax to protect the bronze from future erosion OR buffing and highlighting of the letters and applying a protective clear coat.

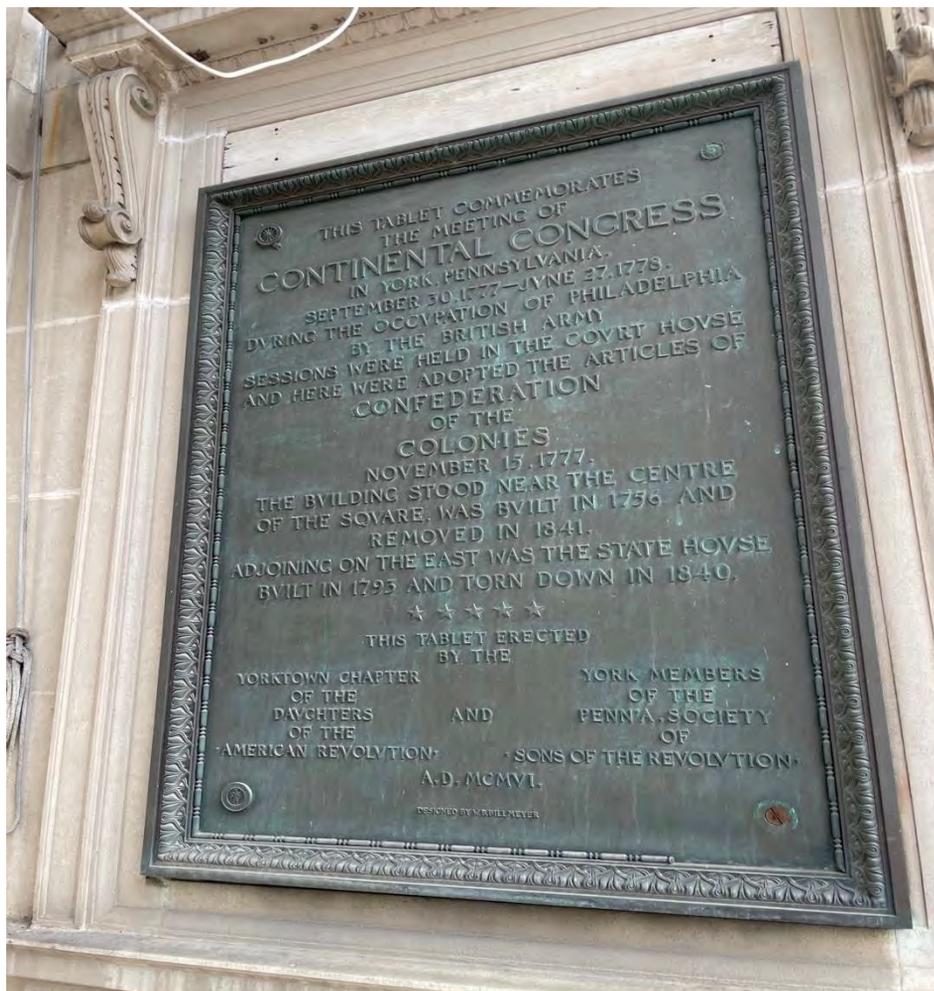
## 1906 Bronze Plaque Continental Congress met here September 1777 – June 1778

**Condition Assessment:** Degradation of the bronze by acid rain (primarily copper sulfates) due to exposure of outdoor environment.

**Action Needed:** Recommend a general cleaning of the bronze. Apply a coat of micro-crystalline wax to protect the bronze from future erosion OR buffing and highlighting of the letters and applying a protective clear coat.

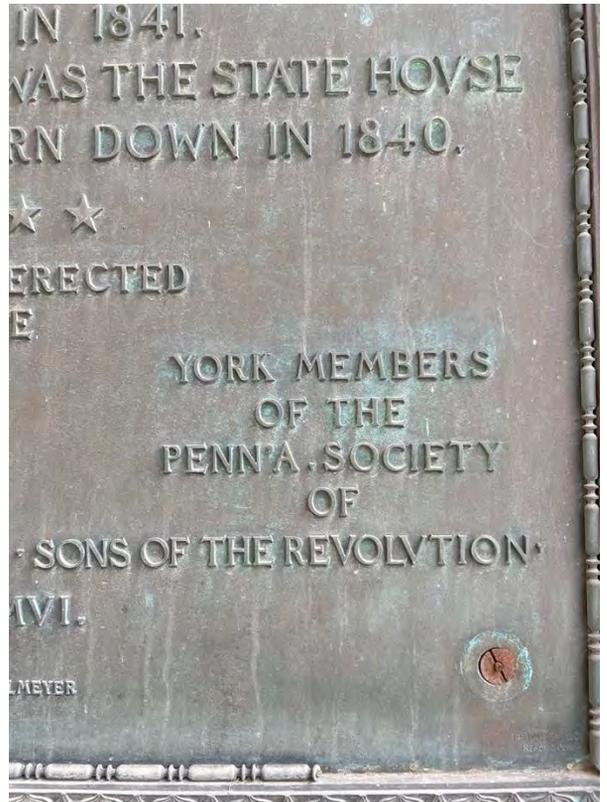
Lower Right-Hand Corner  
The ornamental beading and rosette is missing.

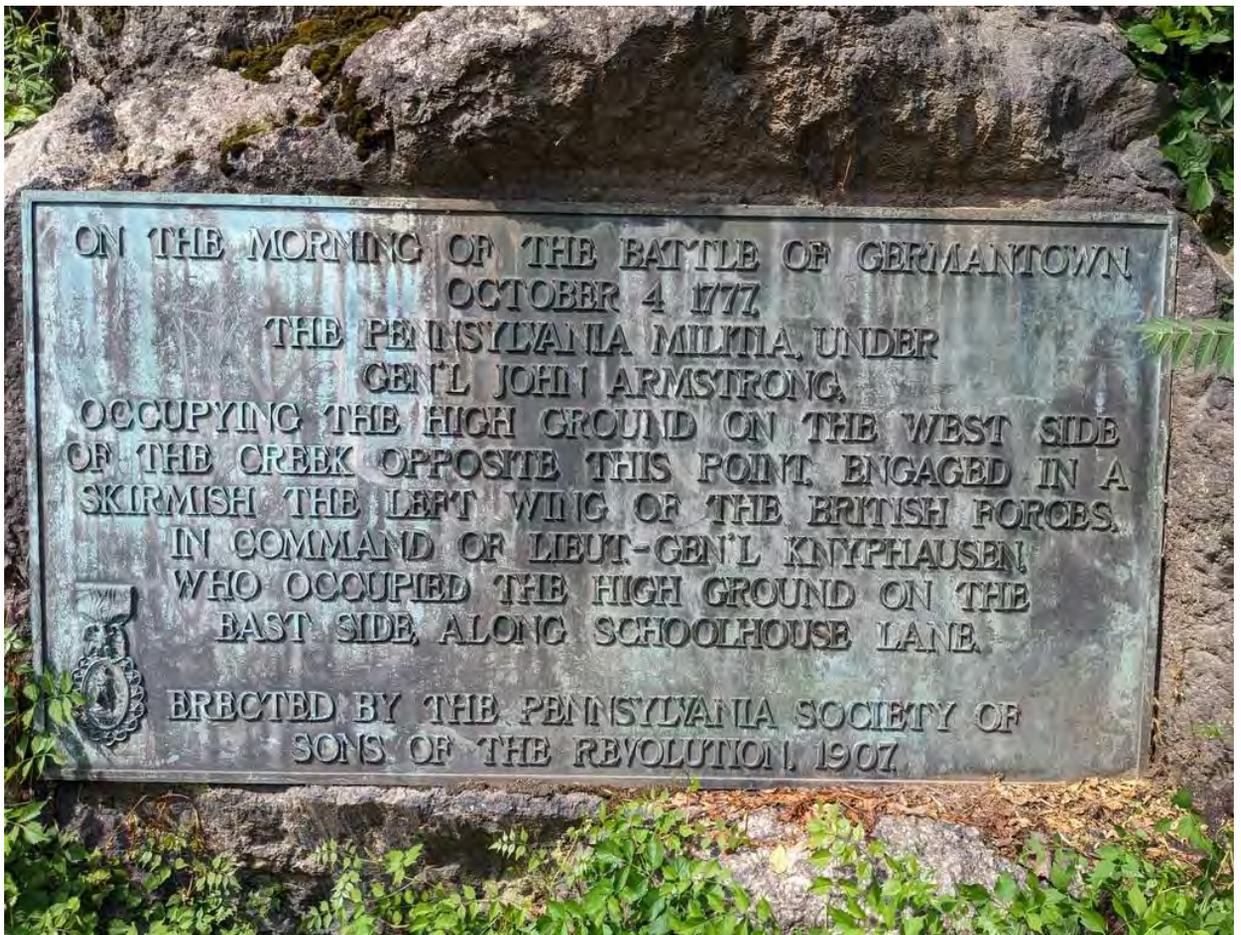
## 1907 Bronze Plaque Action During Battle of Germantown, October 4, 1777

**Condition Assessment:** Degradation of the bronze by acid rain (primarily copper sulfates) due to exposure of outdoor environment.

**Action Needed:** A general cleaning and waxing to preserve the integrity of the bronze. Because of its secluded location, the goal is to not bring high visibility or attention to it due the potential risk for theft and/or vandalism.

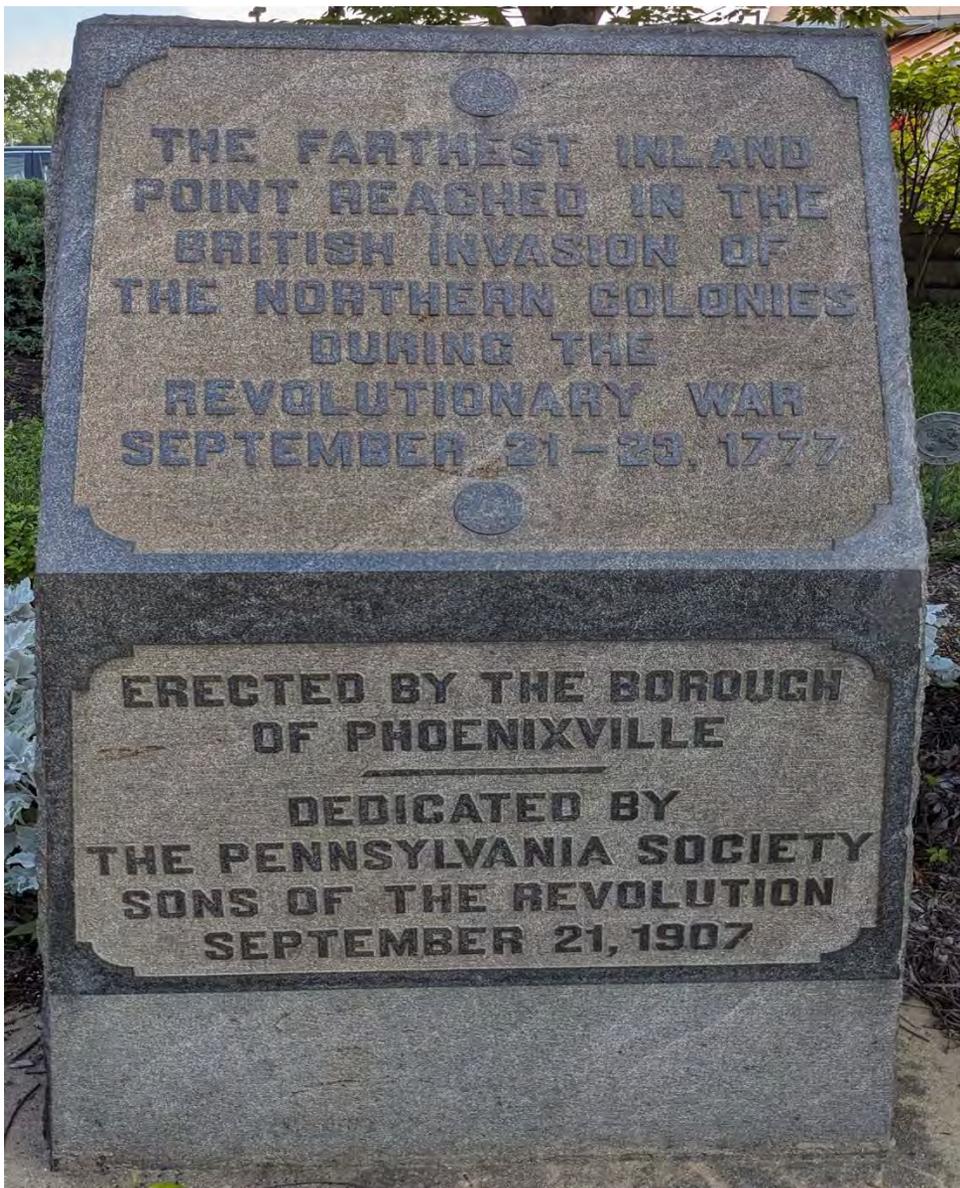
## 1907 Granite Monument The Furthest Inland Point By The British

**Condition Assessment:** Discoloration of granite due to organic materials and high traffic pollutants.

**Action Needed:** A general cleaning is recommended.

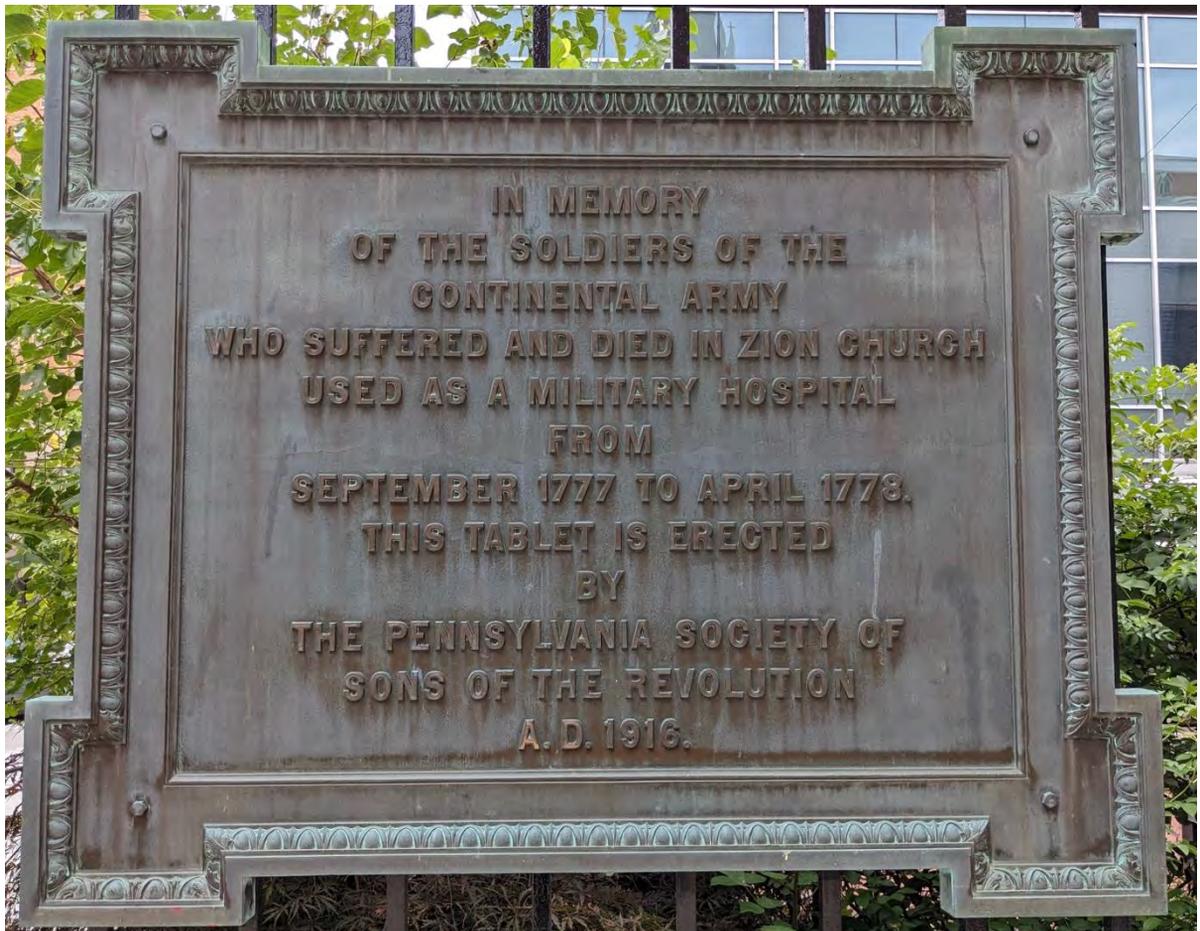
## 1916 Bronze Plaque Continental Army Hospital

**Condition Assessment:** Degradation of the bronze by acid rain (primarily copper sulfates) due to exposure of outdoor environment.

**Action Needed:** A general cleaning and waxing to preserve the integrity of the bronze. Because of its location, the goal is to not bring high visibility or attention to it due the potential risk for theft and/or vandalism.

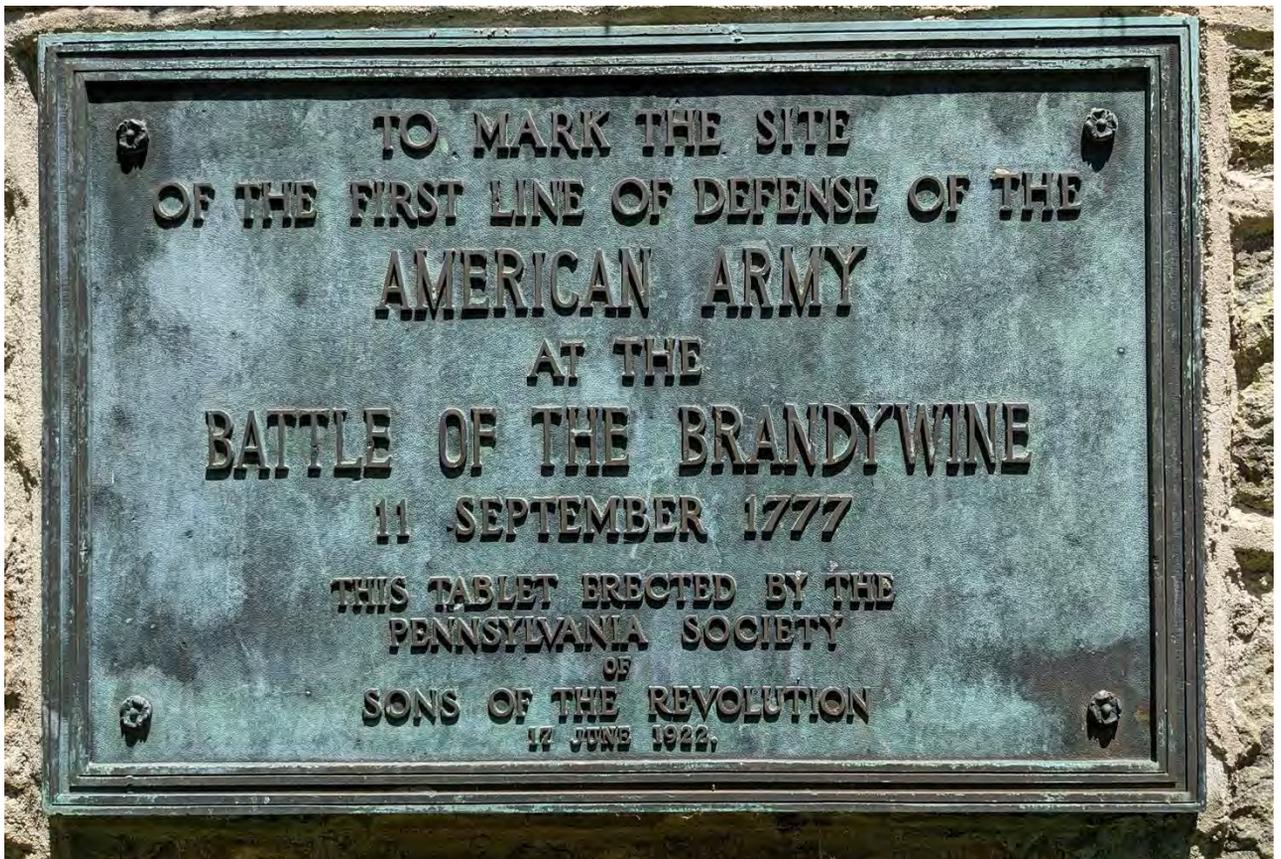
## 1922 Bronze Plaque Battle of Brandywine

**Condition Assessment:** Degradation of the bronze by acid rain (primarily copper sulfates) due to exposure of outdoor environment.

**Action Needed:** Recommend a general cleaning of the bronze. Apply a coat of micro-crystalline wax to protect the bronze from future erosion OR buffing and highlighting of the letters and applying a protective clear coat.

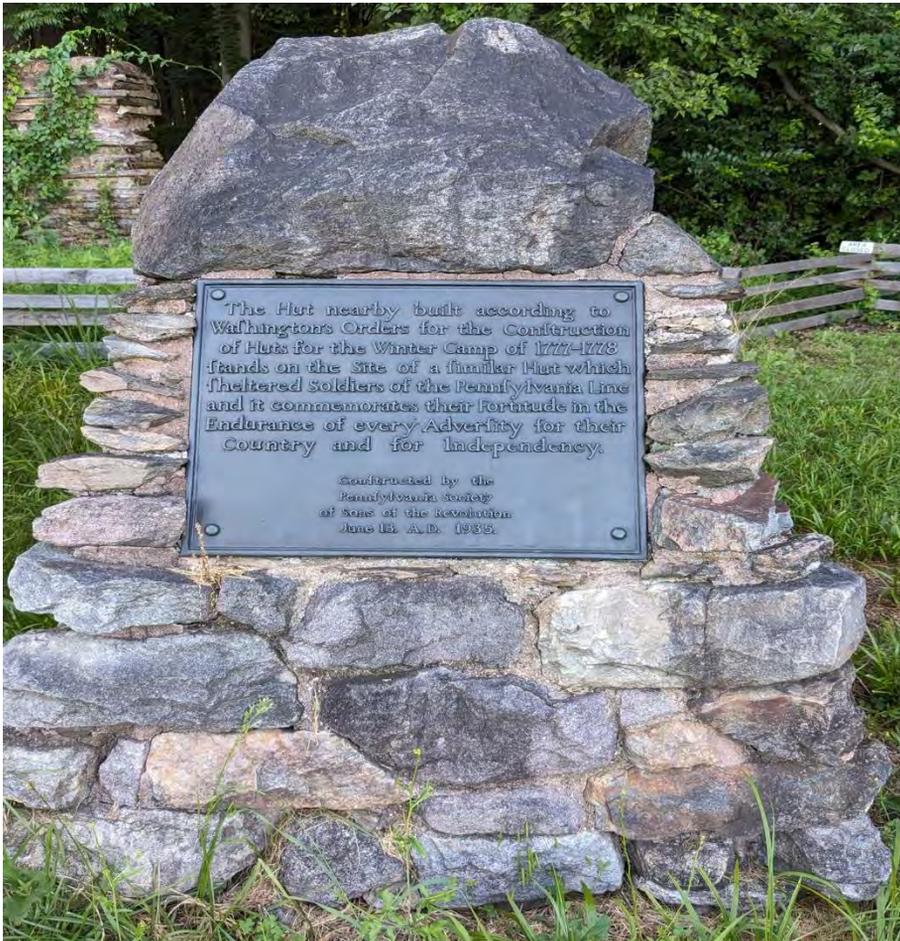
## 1935 Log Hut & Bronze Plaque Soldiers of the Pennsylvania Line

**Condition Assessment:** Degradation of the bronze by acid rain (primarily copper sulfates) due to exposure of outdoor environment.

**Action Needed:** Recommend a general cleaning of the bronze. Apply a coat of micro-crystalline wax to protect the bronze from future erosion OR buffing and highlighting of the letters and applying a protective clear coat.

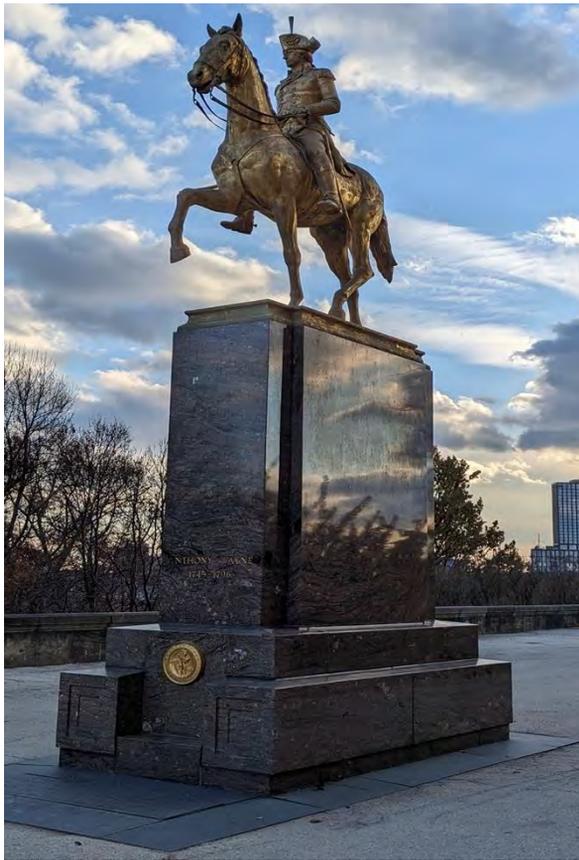
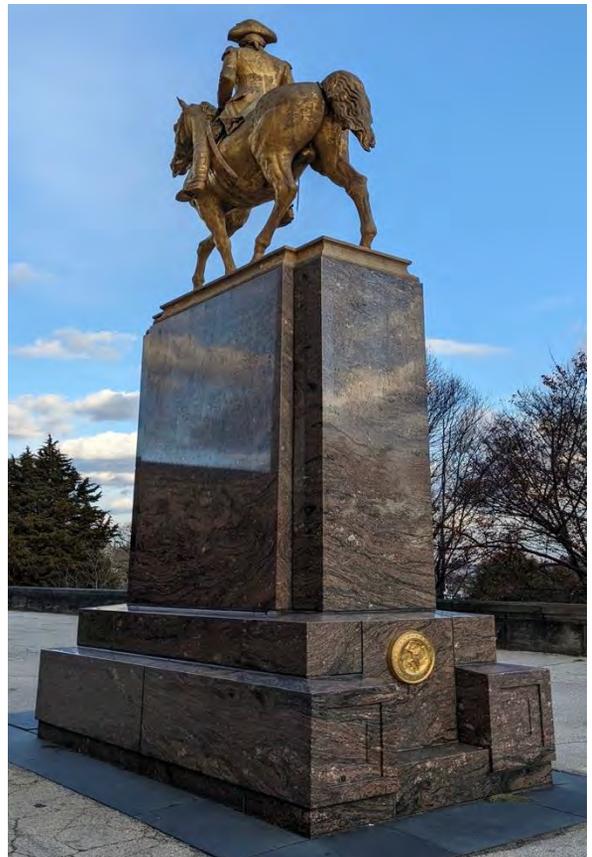
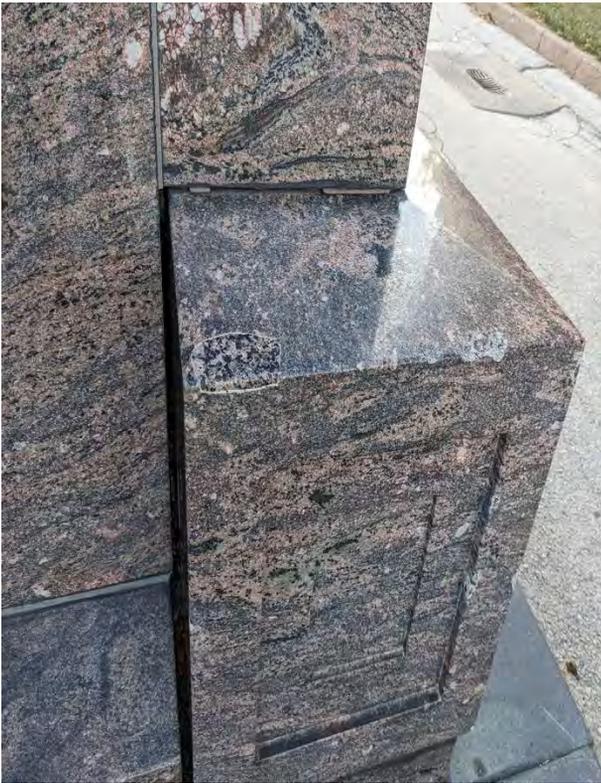
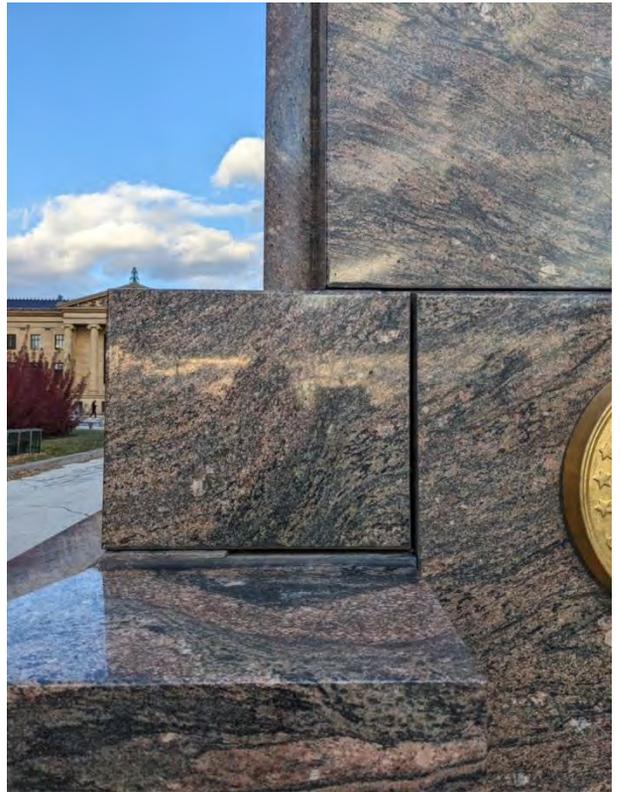
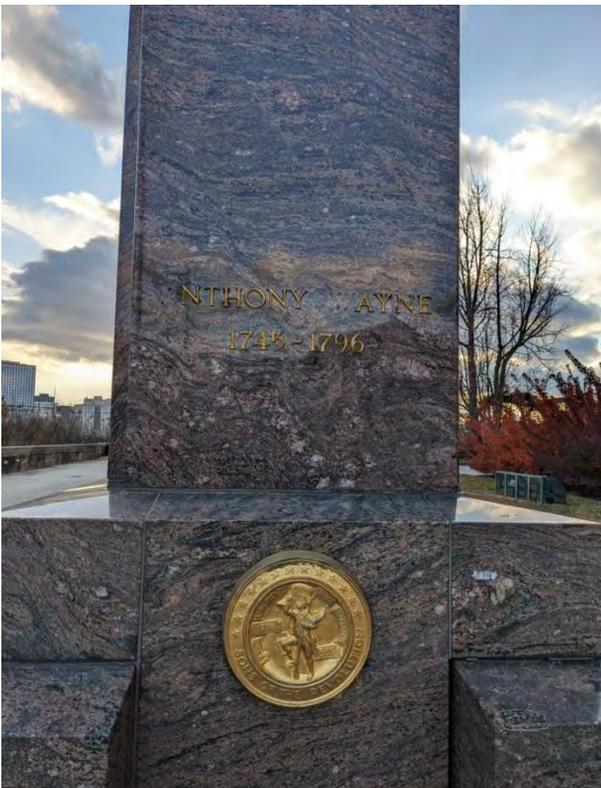
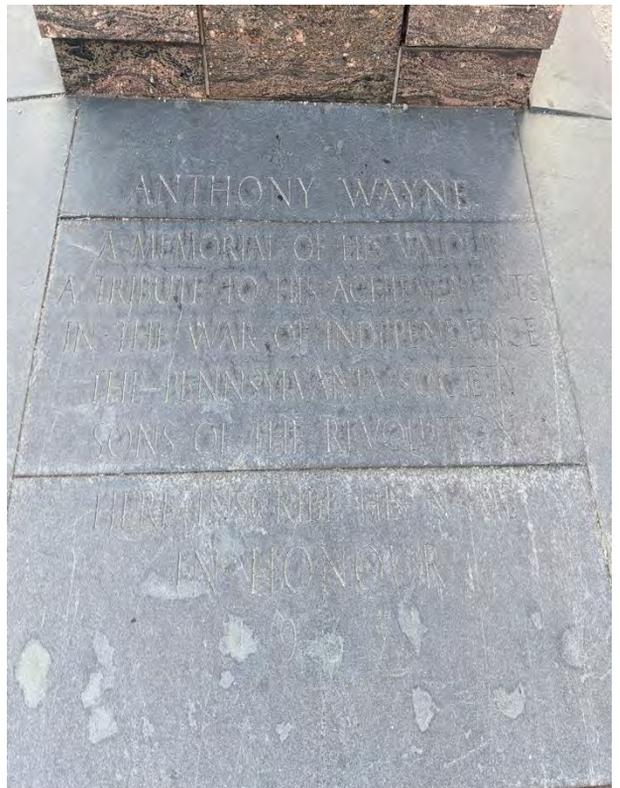
# 1937 Equestrian Statue General Anthony Wayne

**Condition Assessment:** Granite Pedestal 60% of the  
pointing of the granite is missing allowing water and ice to  
get in which causes the freeze and thaw to push the  
granite sections apart.

Granite Pedestal – Rake out all existing mortar joints and  
repoint with an architectural silicone sealant which will  
flex with any movement of the granite. Reset right front  
side first course piece of granite that appears to have  
been hit by a vehicle. At this point in time the pointing is  
more important than regilding of the bronze sculpture.

**This is of high priority.**

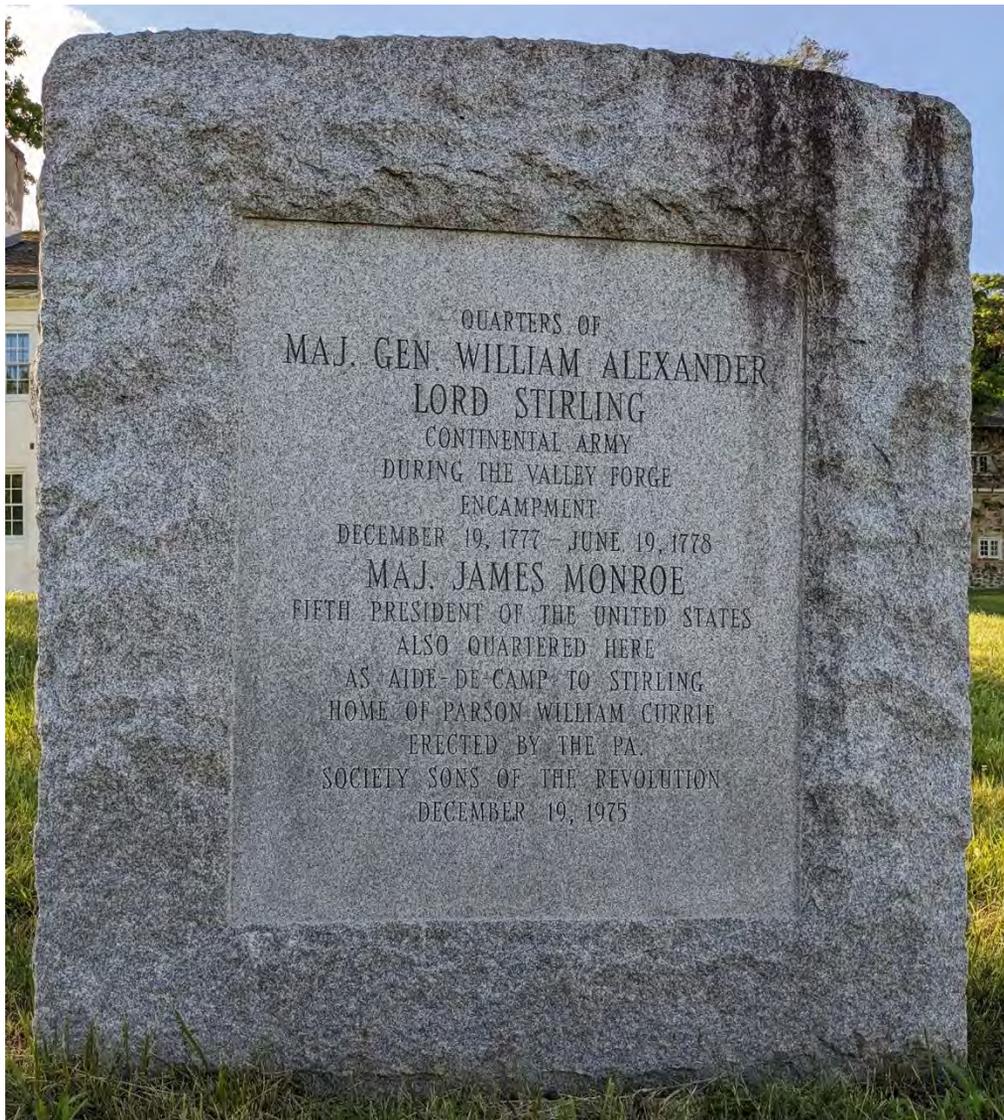
## 1975 Stone Monument Valley Forge Encampment

**Condition Assessment:** Discoloration of granite due to organic materials and high traffic pollutants.

**Action Needed:** A general cleaning is recommended.

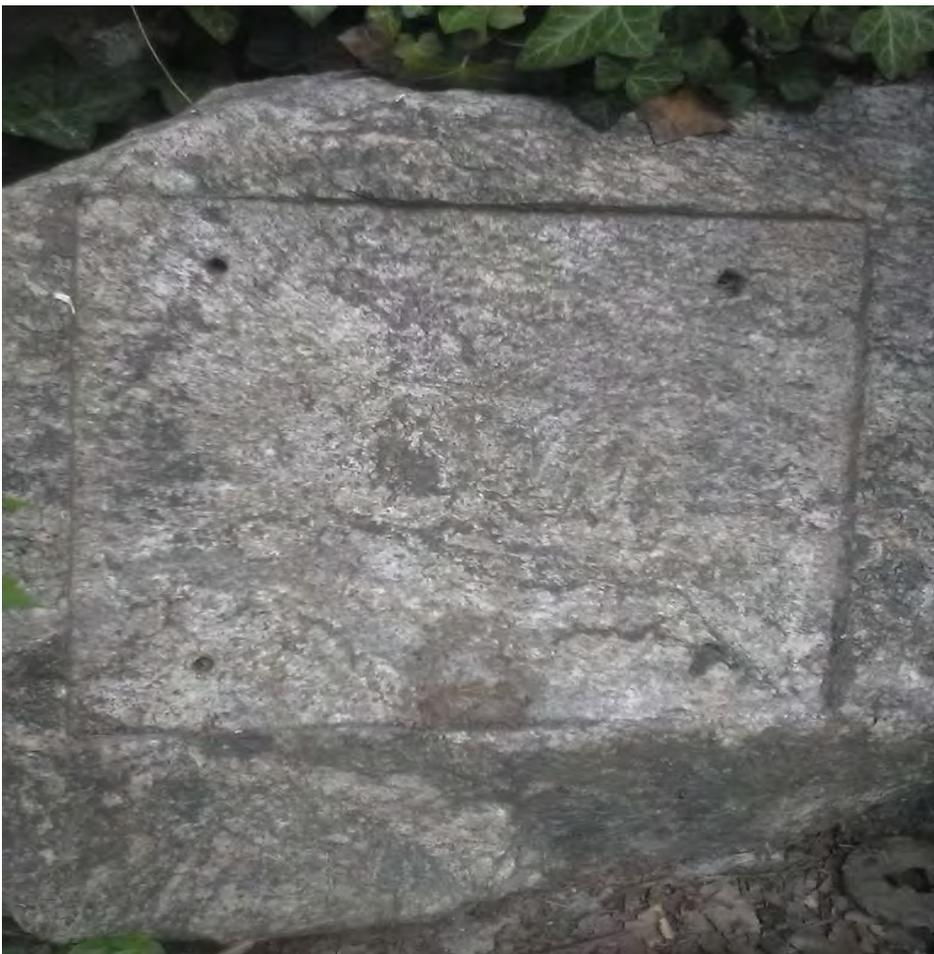
## **1987 Bronze Plaque Site of the Associators**

**Condition Assessment:** Plaque was stolen

Bronze plaque was attached to this boulder.  
This boulder is located outside of the church's property  
on National Park Service Property.

**Action Needed:** Replace plaque – move to a safer place  
within the churchyard.
